JSC-08963

SKYLAB MISSION REPORT  
THIRD VISIT

PREPARED BY  
Mission Evaluation Team

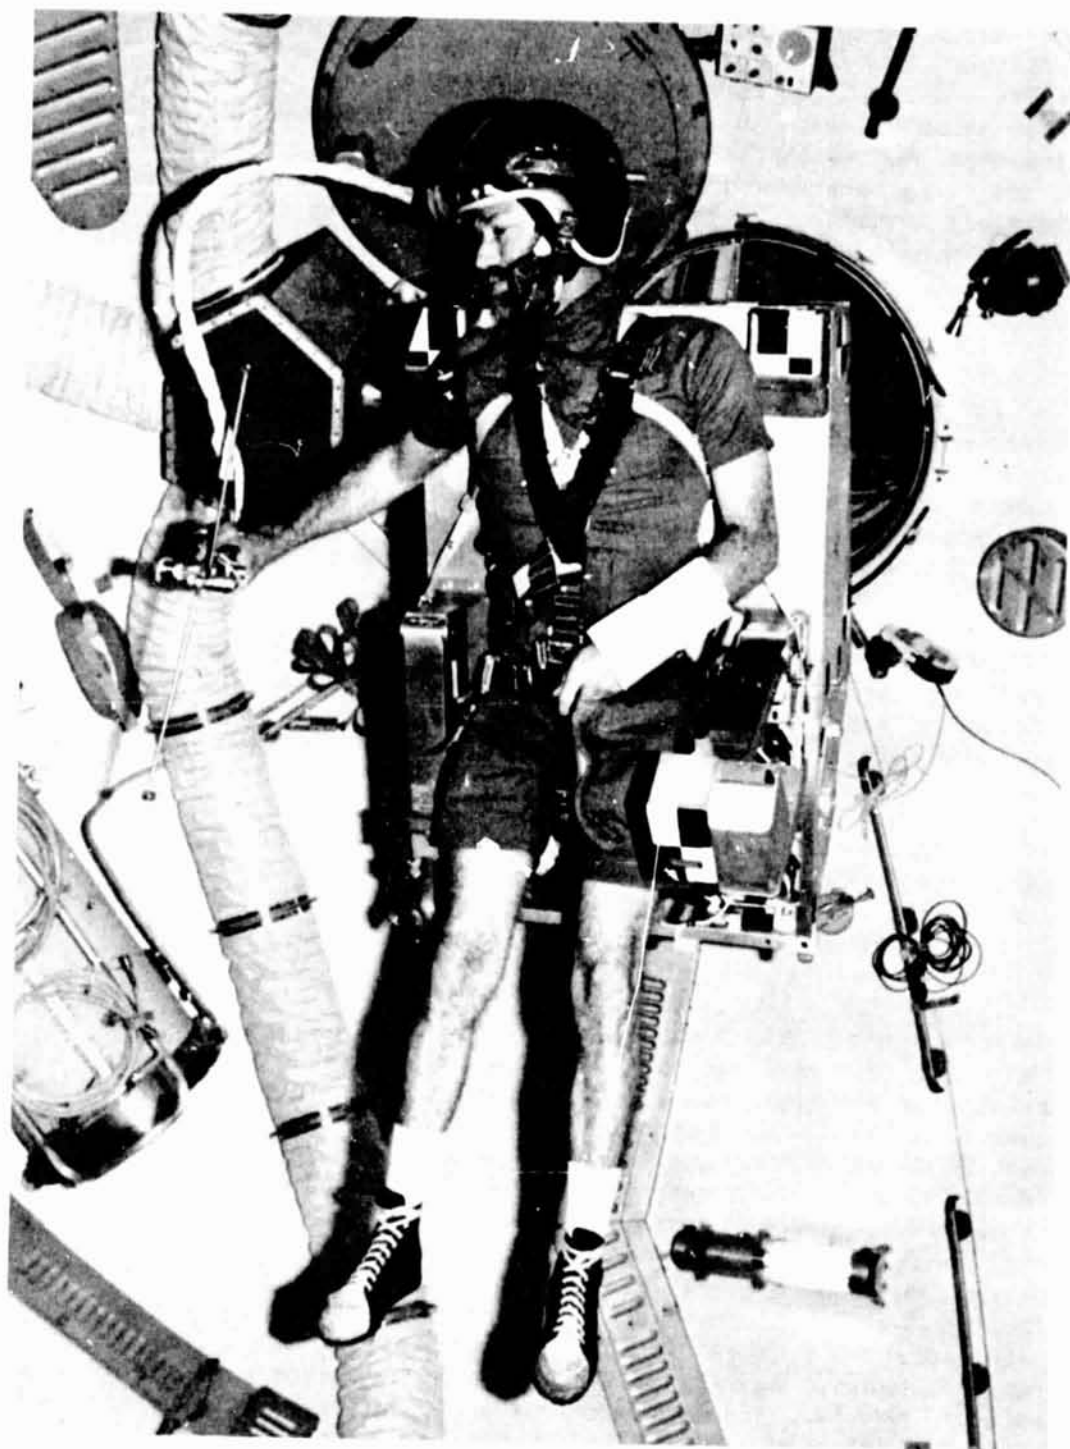
The astronaut maneuvering unit (fig. 9-9) was evaluated as a corollary experiment and, with its stabilization and attitude control system, appeared to be a safe unit to operate outside the vehicle. A light tether of some kind would probably be a desirable feature but, for the most part, the astronaut maneuvering unit is an effective way to move around on the outside of a spacecraft.

Figure 9-9.- Commander operating the hand-held maneuvering unit.

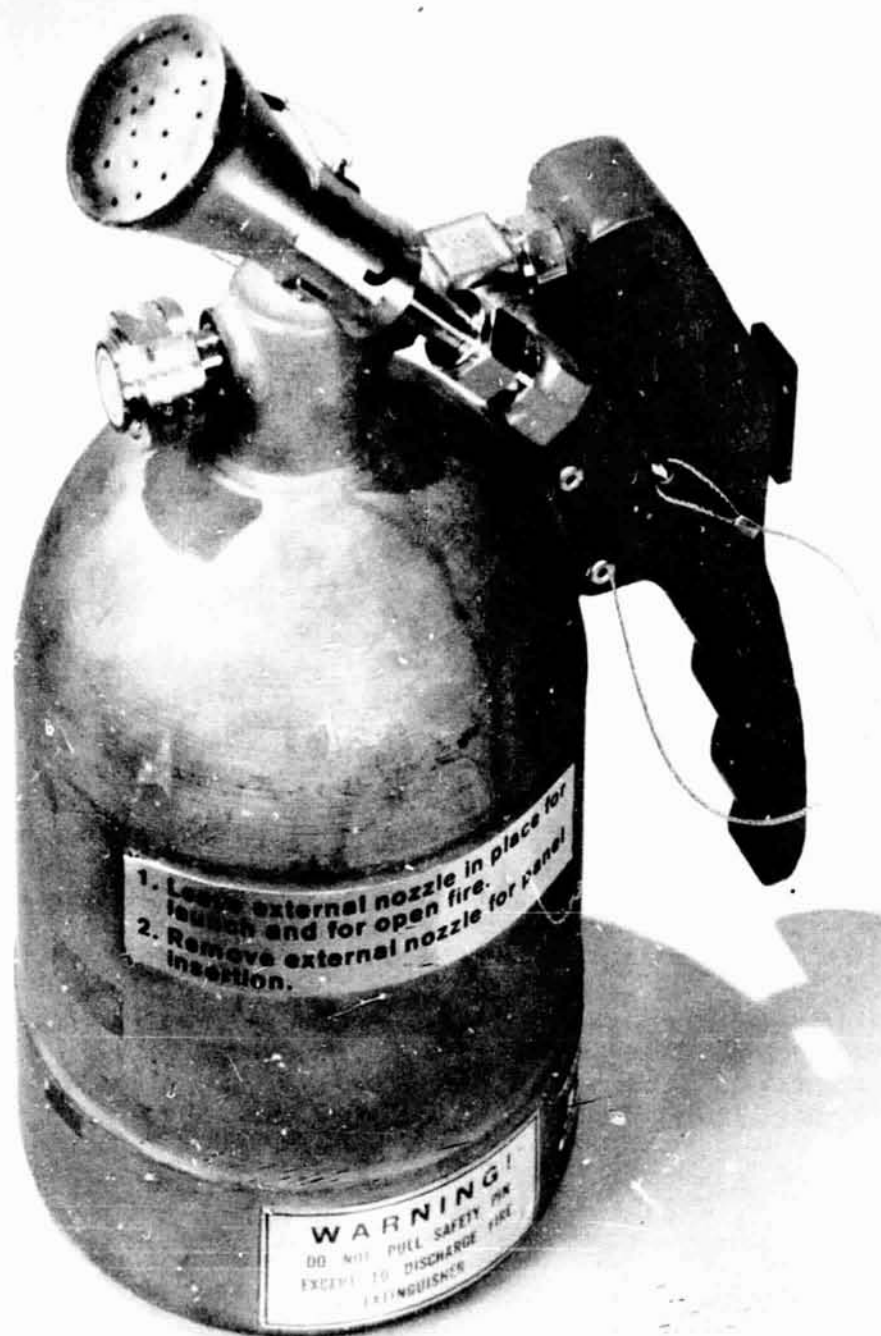
Figure A-1.- Skylab fire extinguisher.
